Yamaha DS6 clutch rebuild

by Stuart Holding, April 2022.

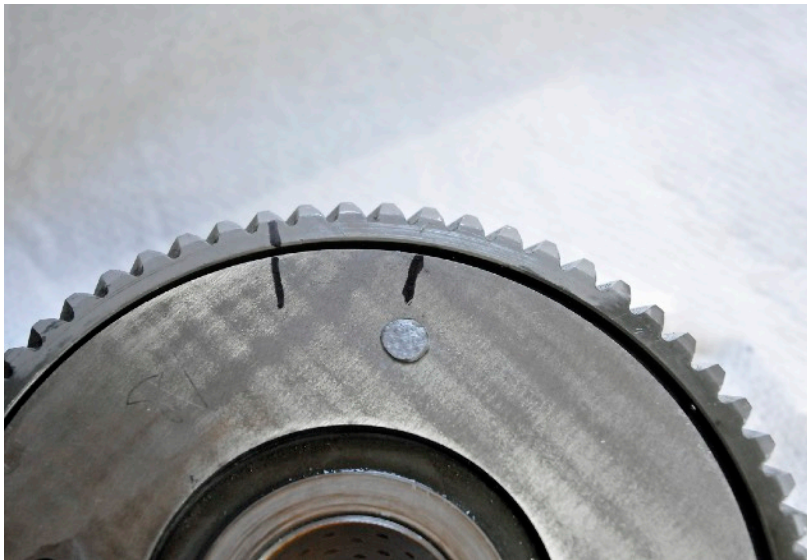
Clutch hub free play

A quick stripdown soon had the clutch on my bench and a ruler put some numbers on the magnitude of the problem. The gear was able to rotate around the periphery of the basket by about an inch. Quite how much it was supposed to rotate was something I had trouble finding out, but I was sure it was never intended to be an inch. Whatever damping system was inside was no longer functional.

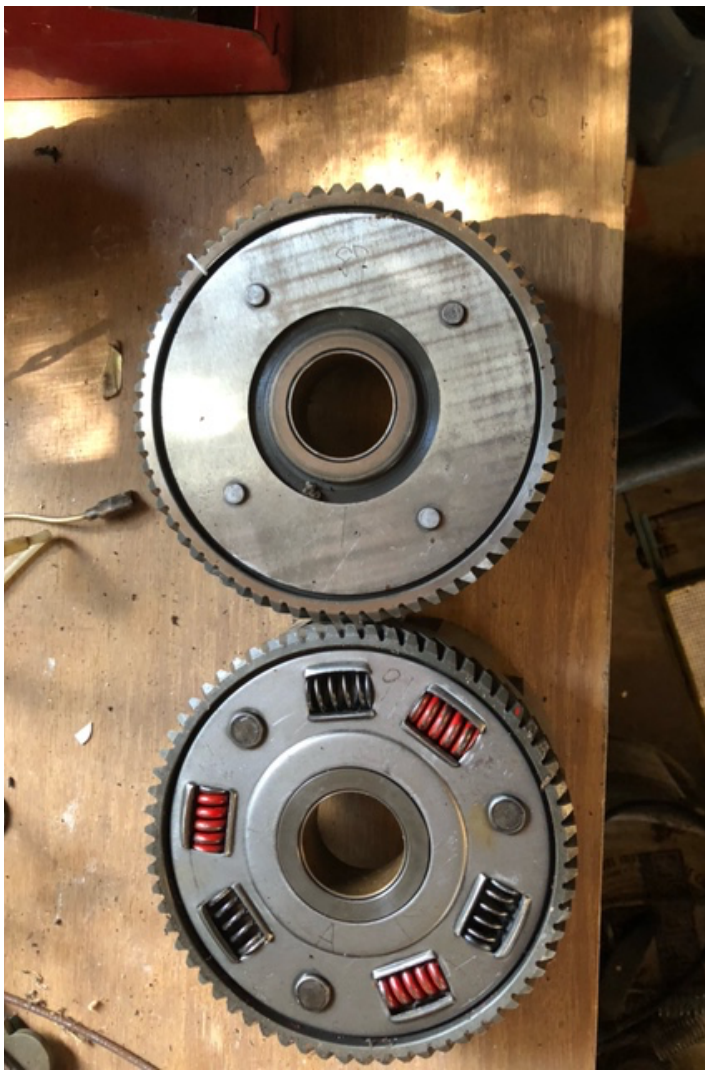
Spring damped and plain clutch hubs

In my Clymer manual there's a sectional diagram of the DS6 clutch and it refers to a 'torsion spring' as the damping mechanism. If there were springs in there and they'd failed, where on earth would I find replacements? Would I be better off trying to find a replacement clutch basket? In a haze of uncertainty I mentioned it to a friend in the US. "I've got a few of those in the barn, I'll go and have a look" he replied. Next day I got an email from him. 'Seems there's two different types. One has springs set into the plate on the back, the other has a riveted plate. The spring versions are from the earlier bikes – DS5's from my bits. The DS6's have the plain plate.' He attached a picture. In it the spring damped hub was obvious. I didn't have that. Mine was the four rivet version. So if it wasn't springs what exactly was in there?

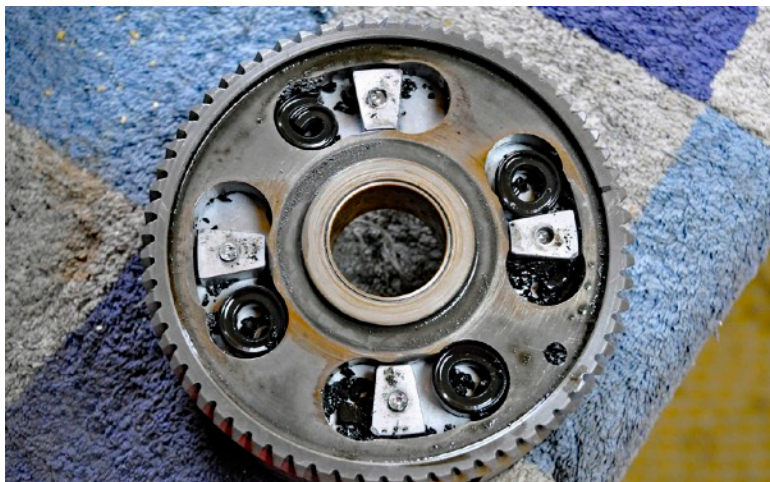
Damping mechanism

With some trepidation I ground the heads off the rivets and removed the plate. The picture shows what I found inside.

It looked as though there were originally eight rubber discs in there but only three of them had survived intact, with a fourth broken and curled in on itself. All of those were on one side of the hub. The other side - the thrust side - had only shredded rubber remnants preventing metal to metal contact. After cleaning the rubber debris out of the hub I had to decide what to replace them with. DS6 parts were not only not available, they never were, even when the bikes were current. But aftermarket discs for the later DS7 and RD250 were available. Whether they would fit or not I had no idea but as they were not that expensive I ordered a set from Yambits along with a set of replacement rivets to reassemble the basket. When they arrived, not only were they exactly the right diameter (22.3mm vs 22.1mm for the somewhat distorted originals) but also virtually the same thickness (9.3mm vs 9.0mm). They fitted perfectly into the hub recesses and reduced the rotational movement to only around a millimetre or two, and that dependant solely on the rubber compressing.

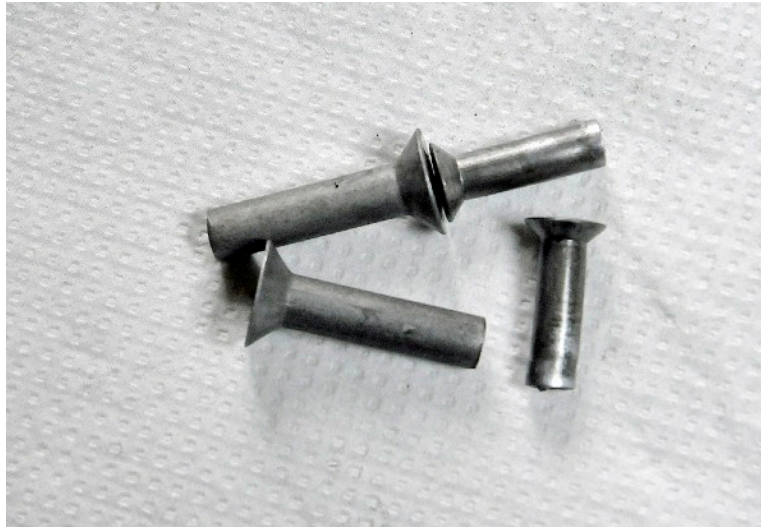
Old vs new rivets

The rivets however were not such good news. The replacements were 6mm diameter versus the original's 5mm and so would not fit without drilling out the holes - something I was reluctant to do. The countersunk heads were also 2mm wider than the originals and would need reducing to fit the basket recesses. The prospect of having to try and peen the rivet heads was also something I could not do satisfactorily. In the end I decided to tap each of the 5mm holes to M6 and use high tensile screws plus permanent grade Loctite on the basis that if it didn't work I could still use the larger rivets. Screws plus Loctite is the method used by a number of aftermarket clutch suppliers (mainly in the MX world) so it wasn't completely a step into the unknown. A local screw supplier came up with some 16mm low head socket screws and much to my delight there was enough clearance behind the hub that the screw heads didn't catch on anything. Only time will tell if the screws are a strong enough answer but they seem to be ok so far. If all else fails the spare clutch hub shown in the second picture has my name on it but I'm hoping it won't be needed.
